TECHNICAL BULLETIN

ULTRA UV • July 1, 2016

Non-Warrantable Conditions

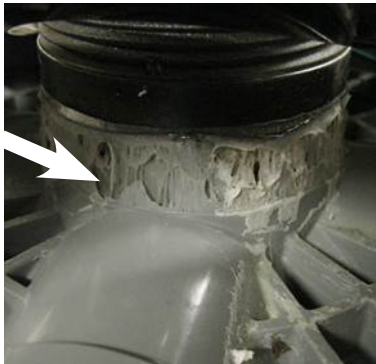
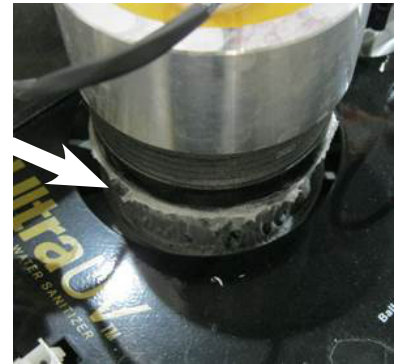
Fig. 1

A squeeze out (see Fig 1 & 2) happens when there is a NO OR LOW FLOW condition in an Ultra U.V. This causes the pressure switch to activate the ballast and illuminate the lamps, but does not achieve adequate cooling around the quartz tube. The most common cause of this LOW OR NO FLOW condition is a partially or a completely open by-pass. Another cause is improper plumbing that would result in the pressure switch being activated with a LOW OR NO Flow condition. It can also happen if the pressure switch is by-passed with both wires connected to a "WYE" (See Fig 3). The "WYE" was supplied on older Ultra UVs. Finally, if a unit is installed below water level and the option "Flow Switch" was not used the pressure switch could activate when the system is off and over heat causing a squeeze out when the unit is put under pressure. The Ultra UV requires 100% of the system flow from the filter outlet to pass through the Ultra UV. If it is a 3 lamp unit, it requires 2 inlets and 2 outlets to be plumbed. Please see attached By-Pass tech bulletin and the instructions for plumbing multiple ports.

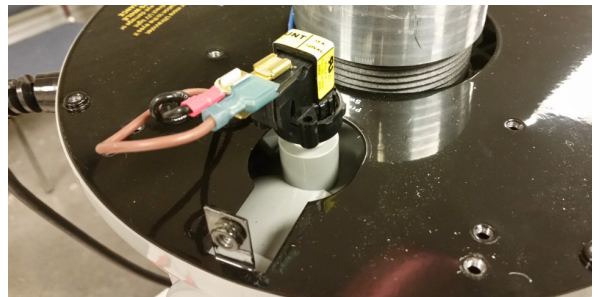
Fig. 3

Both leads connected to Y connector.

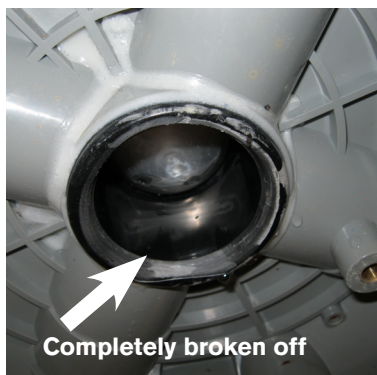
Fig. 4

This occurs when winterizing is not done properly. The UV unit must be removed at the unions and tipping the tank to a horizontal position so all the water is drained from the unit. Special attention must be paid to draining the water captured in the cup holding the crystal tube at the bottom of the unit. An alternative way is to loosen the unions so the water drains out and then remove the lid, lamp assembly, and crystal and use a wet or dry vacuum to remove all the standing water. Failure to remove all the water from the unit will result in freezing damage to the tank and is not covered under the warranty. It is also recommended to remove the unit from the plumbing and store it in an area that does not freeze.

Completely broken off

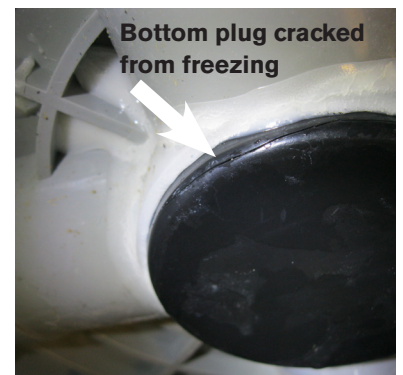
Fig. 5

Bottom plug cracked from freezing
